Recent catastrophic landslide lake outburst floods in the Himalayan mountain range

Progress in Physical Geography 2017, Vol. 41(1) 3–28 © The Author(s) 2016 Reprints and permission: sagepub.co.uk/journalsPermissions.nav DOI: 10.1177/0309133316658614 journals.sagepub.com/home/ppg

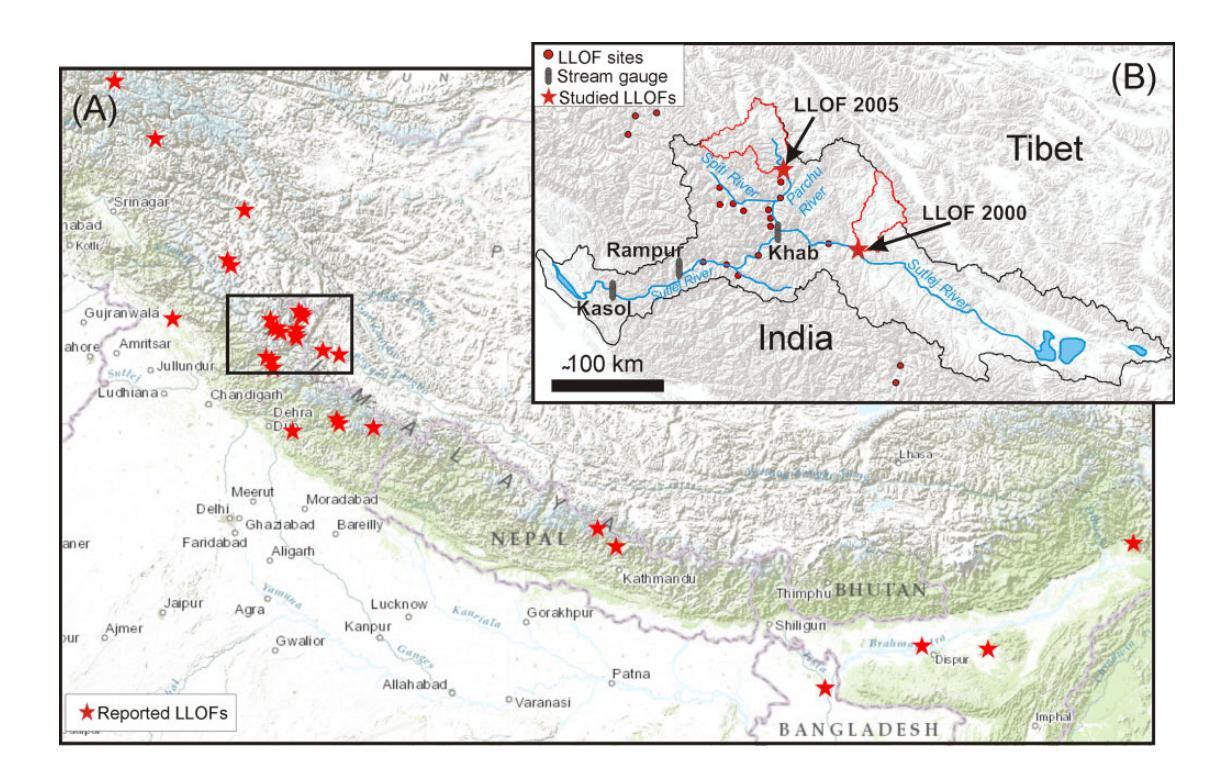
Figure 1. (a) Catastrophic LLOFs in the Himalayan Range extracted from bibliography and (b) observed dams and the two LLOF analysed in this work in the Upper Sutlej River Basin.

Numerous catastrophic outburst floods have occurred during the Holocene in many areas of the Tibet-Himalayan orogeny (Figure 1; Cenderelli and Wohl, 2003; Hewitt, 1988, 1998; Richardson and Reynolds, 2000; Shroder,

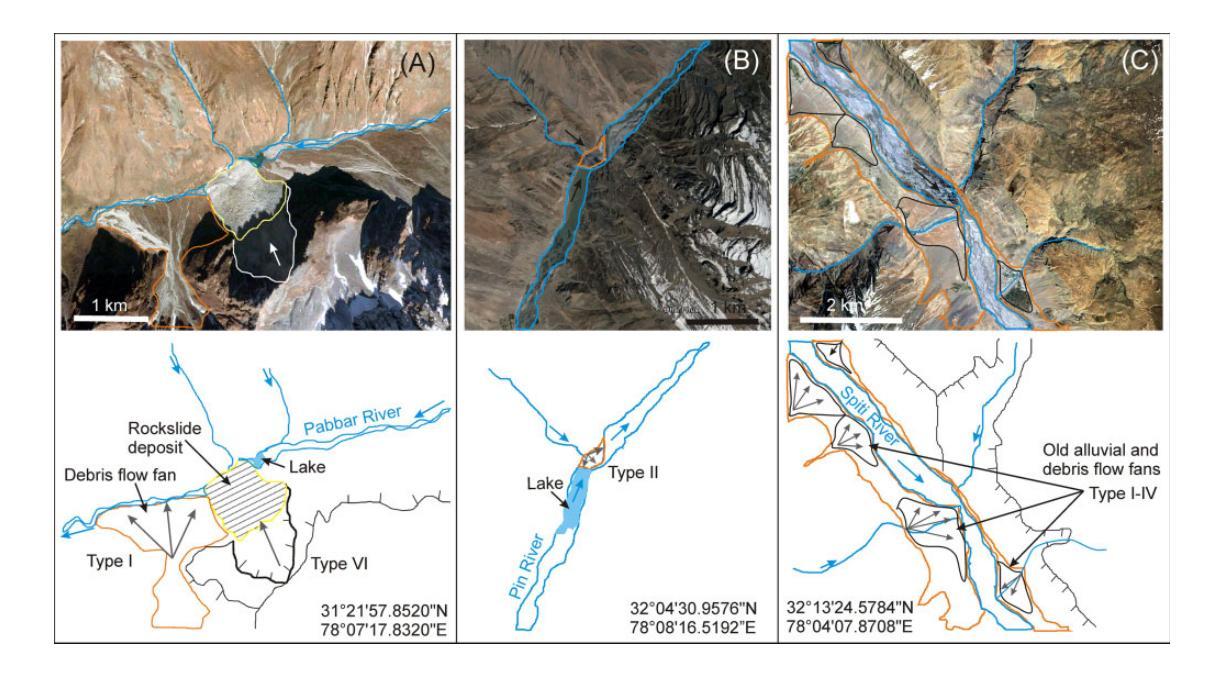
Figure 2. Examples of LLOF evidence in the Upper Sutlej River Basin: (a) alluvial fan with recent debris-flow deposits and rock slide/avalanche occurred in 1997 (Pabbar River hillslopes); (b) debris flow fan deposit, with dam likely formed between 2010 and 2012 (Pin River basin); (c) ancient alluvial fans in Spiti River valley located close to Kaza. Images are from Google Earth 2014. Dam types referred to the geomorphic classification by Costa and Schuster (1987).

Figure 2 shows examples of river damming events in the Pabbar, Pin, and Spiti Rivers. According to the classification proposed by Costa and Schuster (1987), most of the river dams are types I, II, III and V (i.e. tributary valley source and main valley source with upvalley and downvalley lobes with a T shape). For the most recent decades, documentary evidence provides a record of several major LLOF events in the region (Table 1). At least nine events in the Sutlei River basin occurred since 1973, and these events occurred both as a result of seismic and from aseismic triggering. In the following we will focus our analyses on the recent, devastating and trans-national events of 2000 and 2005.

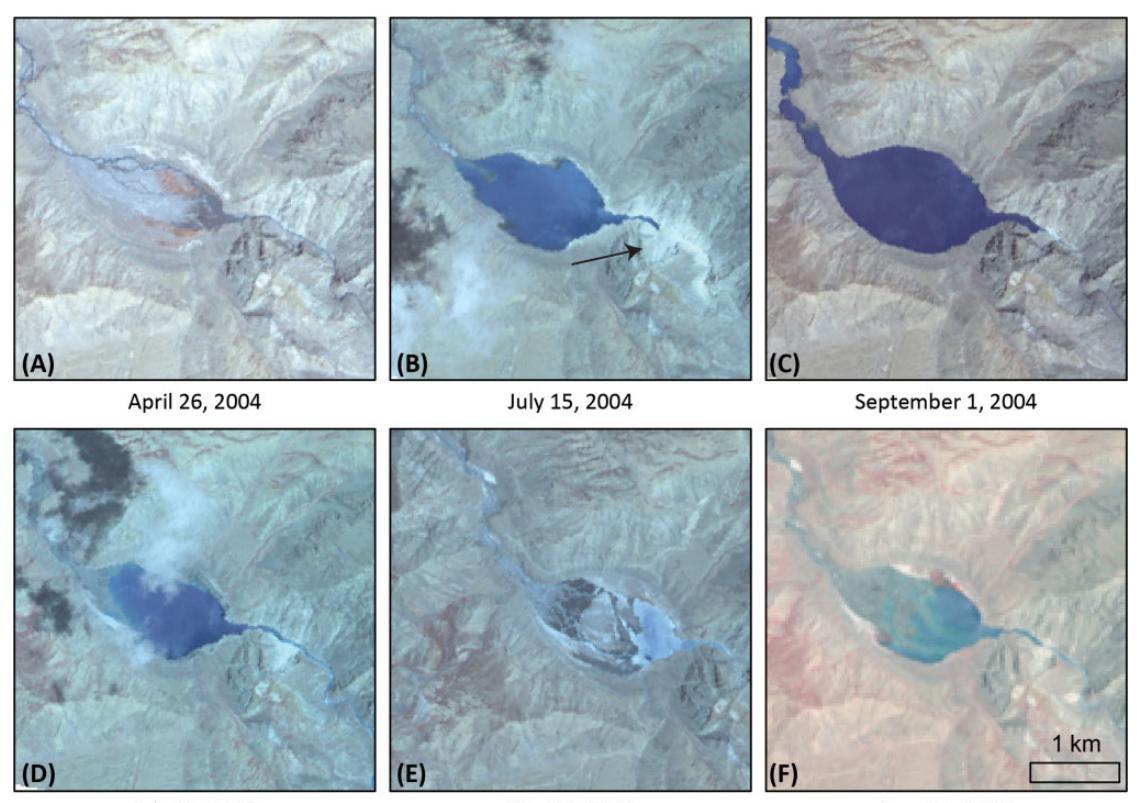
Figure 3. Series of Landsat images showing the formation of the landslide dam and filling of Parchu Lake (32°19'36.13"N; 78°43'10.42"E) in late April 2004 (a), and catastrophic failure of the dam and outburst flood in 2005, followed by subsequent enlargement of the lake again in June 2013. The landslide deposit which formed the dam is clearly evident as a lighter coloured deposit on 15 July 2004 (see arrow in b). Outflow from the lake is clearly visible on 2 July 2005, nearly 1 week after the catastrophic breaching of the dam (d). Over subsequent years the lake remained either empty or with a small volume of water accumulating (e). In June 2013 local authorities had renewed concern as the lake volume increased again to significant levels (f).

Based on satellite image interpretation, the formation of the landslide dam first becomes evident between 13 and 29 June 2004. The resulting dust and deposit from the slope failure, and already significant lake formation is seen clearly in a Landsat image taken on July 15 of the same year (Figure 3).

Distinctive horizontal margins on the sides of the lake basin provide evidence of previous lake levels within the basin. These former lake shorelines provide a clear reference against which the significant increase in lake water level during 2004 can be observed. Already in late July, 2004, India media reported overflow from the lake which caused flood alerts to be sounded, and hydropower projects were temporarily shut down due to the increased sediment load in the river. Some seepage and/or possible overtopping of the lake dam is evident when the lake appears at near full capacity in September 2004 (Figure 3(c)), but the lake level remains constant through until the following spring. Following the catastrophic failure of the dam on 26 June 2005, the first cloud-free satellite image is

available nearly one week later on 2 July, by which time the lake level has dropped by approximately 30-40 m, the dam area appears to be completely eroded, and considerable outflow is visible downstream (Figure 3(d)). At the upstream end of the lake, sediments become increasingly visible as the lake water receded slowly over subsequent years, until only some remnant water remains pooled at the downstream end of the lake (Figure 3(e)). Local authorities became concerned when rising water levels were observed in the lake again in late June 2013, although outflow from the lake at this time appeared to be unobstructed and the lake level never reached the levels seen in 2004/ 05 (Figure 3(f)).

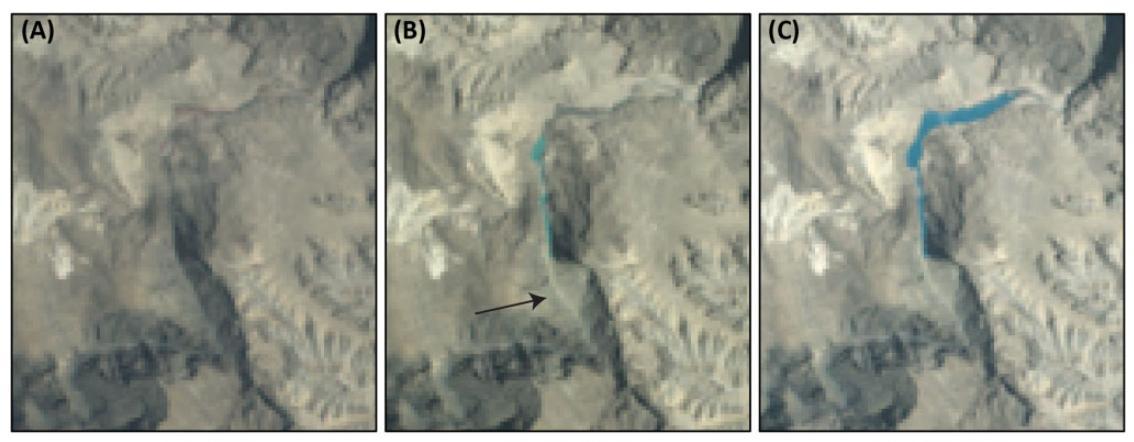
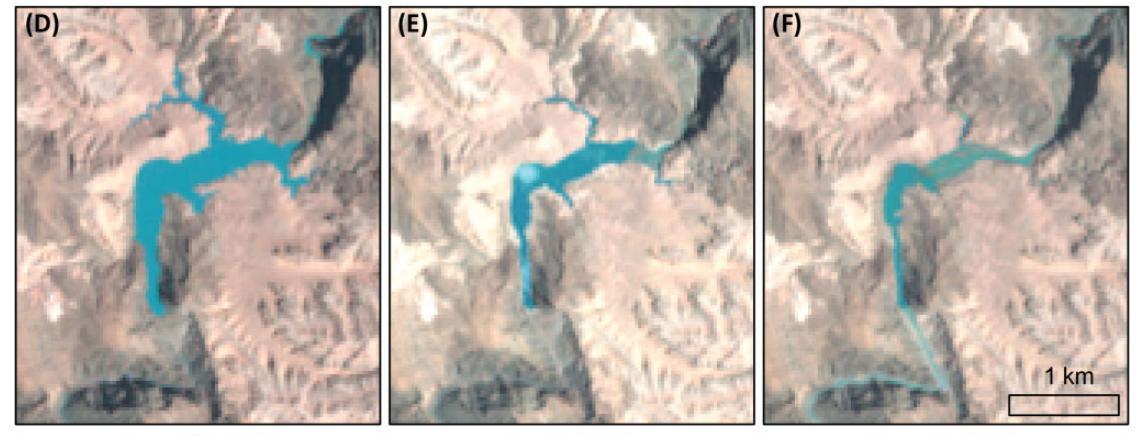
Figure 4. Series of Landsat images showing the formation of the landslide dam and unnamed lake (31°36′56.61″N; 79°29′49.99″E) between 1992 and 1993, and subsequent failure of the dam and outburst flood in 2000. The landslide deposit which formed the dam is first evident as a lighter coloured deposit on 22 May 1993 (see arrow in b). Over the subsequent years, the lake is seen to reach its largest size toward the end of each monsoon season (e.g. d), where some seepage also becomes occasionally evident below the dam area. On 2 June 2000, the lake appears somewhat smaller prior to the onset of seasonal rainfall (e), and subsequent failure of the dam area and outflow from the lake is clearly evident on 5 August 2000 (f).

The exact source of the flash flood that damaged villages along the Sutlej valley in the Indian district of Kinnaur in July 2000 was previously unknown, although landslide damming and subsequent breaching of a lake somewhere in the Tibetan headwaters of the Sutlej River was suspected (Gupta and Sah 2008). Based on satellite image interpretation, we have identified the source as an unnamed landslide dammed lake (31°36′56.61″N; 79°29′49.99″E) located approximately 100 km upstream from the Indo-China boarder (Figure 1). The distinctive light coloured landslide deposit which dammed the river first became evident between images taken June 1992 and late May 1993, with the lake rapidly filling over the subsequent months (Figure 4(a) to (c)). Large blocks still remaining from the landslide deposit are visible in Google Earth imagery. The landslide dammed lake persisted for several years, generally reaching maximum capacity in July-August of each year, following the onset of monsoon precipitation in the region (e.g. Figure 4(d)). At maximum capacity the lake extended upstream for ~ 2.5 km, and had a total area of $\sim 0.5 \text{ km}^2$. Estimated depths measured from profiles taken across the former lakebed in Google Earth (based on SRTM 90 m), range from 10-20 m, giving an estimated lake volume in the range of 5–10 million m^3 . At the beginning of June 2000, prior to any onset of seasonal rainfall, the lake is somewhat below full capacity (Figure 4(e)), and no seepage or overtopping of the dam is evident. Some overtopping and breaching of the dam may have initiated already at the end of June, followed by the complete failure of the dam towards the end of July. A Landsat image on 5 August 2000, 5 days after peak discharge was measured (see next section), shows the dam to have breached with considerable outflow evident (Figure 4(f)).

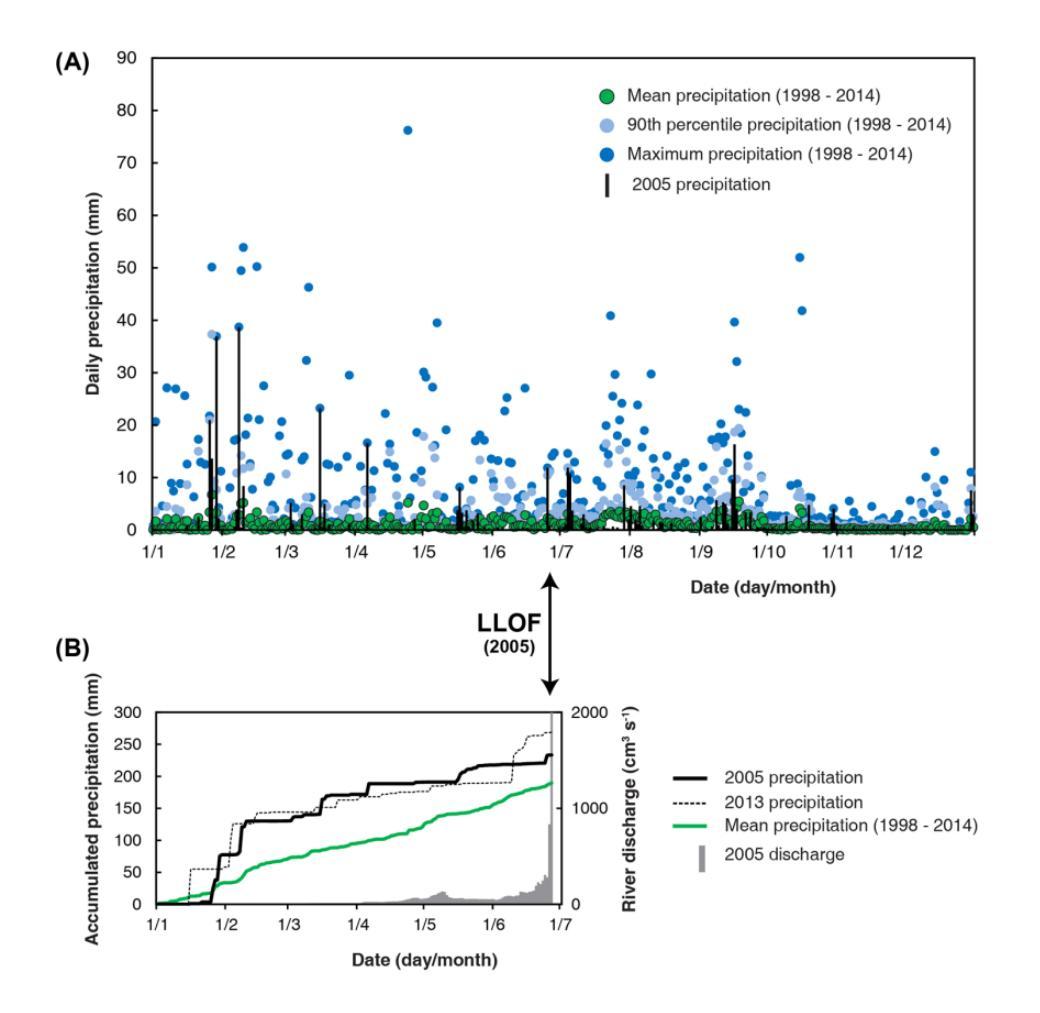
Figure 5. Tropical Rainfall Measurement Mission (TRMM) area averaged daily precipitation over the watershed area of Parchu Lake: (a) Daily measurements during 2005 and 2013 are compared to the longer-term (1998–2014) mean, maximum, and 90th percentile values. (b) Accumulated daily precipitation in 2005 is compared to the longer-term mean, and with daily stream discharge measurements at Khab during 2005. Also indicated is the accumulated daily precipitation during 2013.

Only modest precipitation amounts were recorded over the subsequent months, including 12 mm (25 and 26 June) immediately preceding the outburst flood (Figures 5 and 7(a)). Interestingly, the seasonal accumulation of precipitation through winter and into spring 2013 (i.e. at the time when the lake again reached threatening levels) followed a remarkably similar pattern as 2005, although spring

2013 was tail-ended by a significant precipitation event in mid-June (Figure 5(b)).

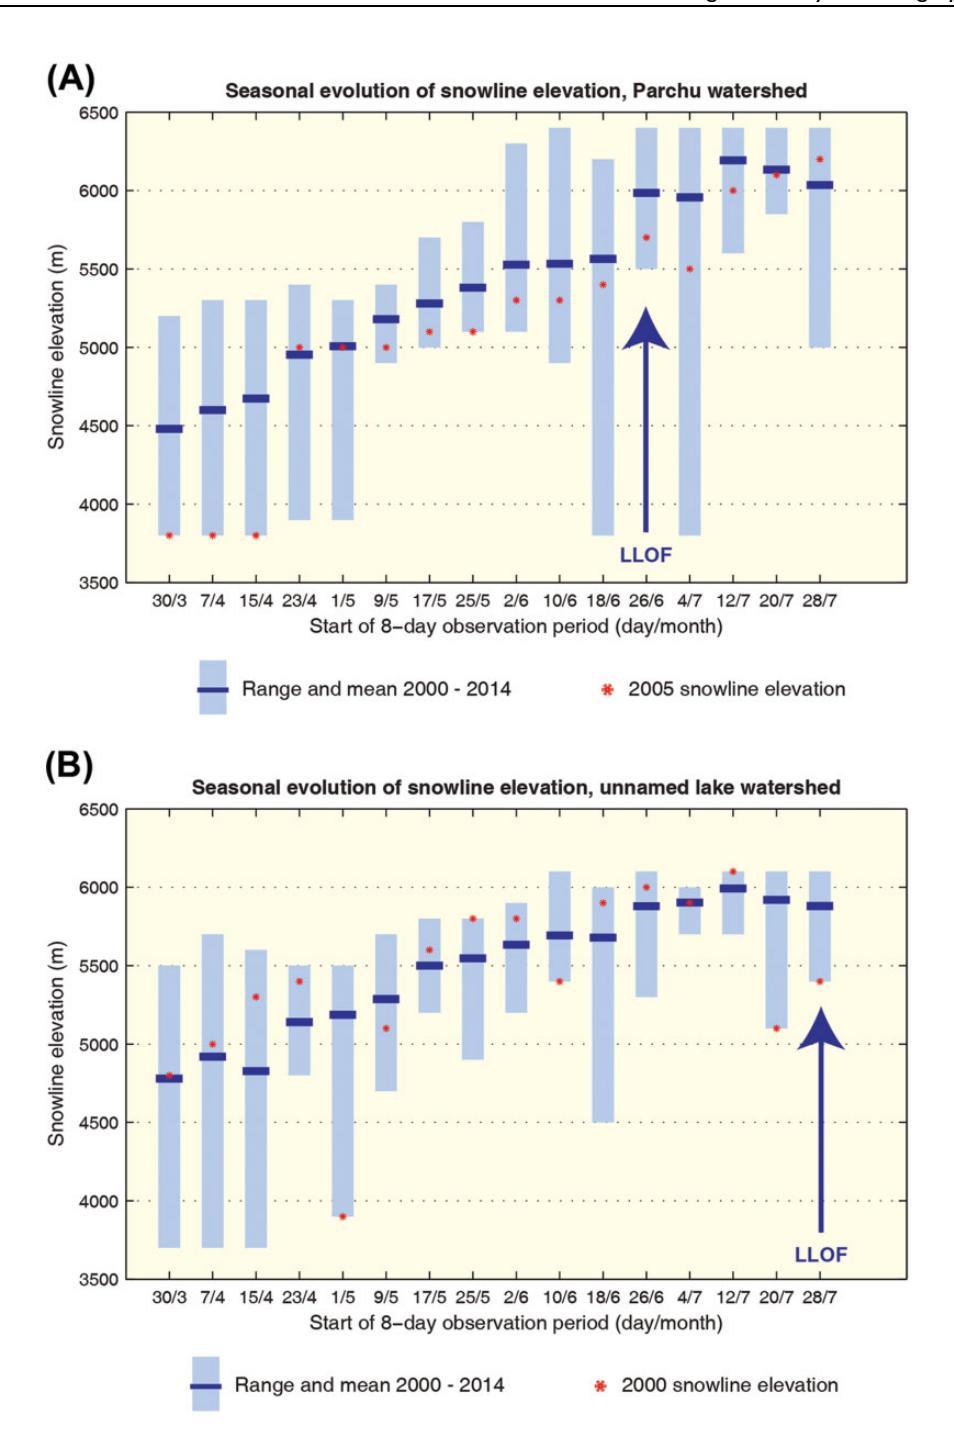
Figure 6. MODIS derived evolution of snowline elevation within the watershed area of (a) Parchu Lake, and (b) the unnamed Tibetan lake. Values measured during (a) 2005 and (b) 2000 are compared to the longer-term range and mean values for the years 2000–2014.

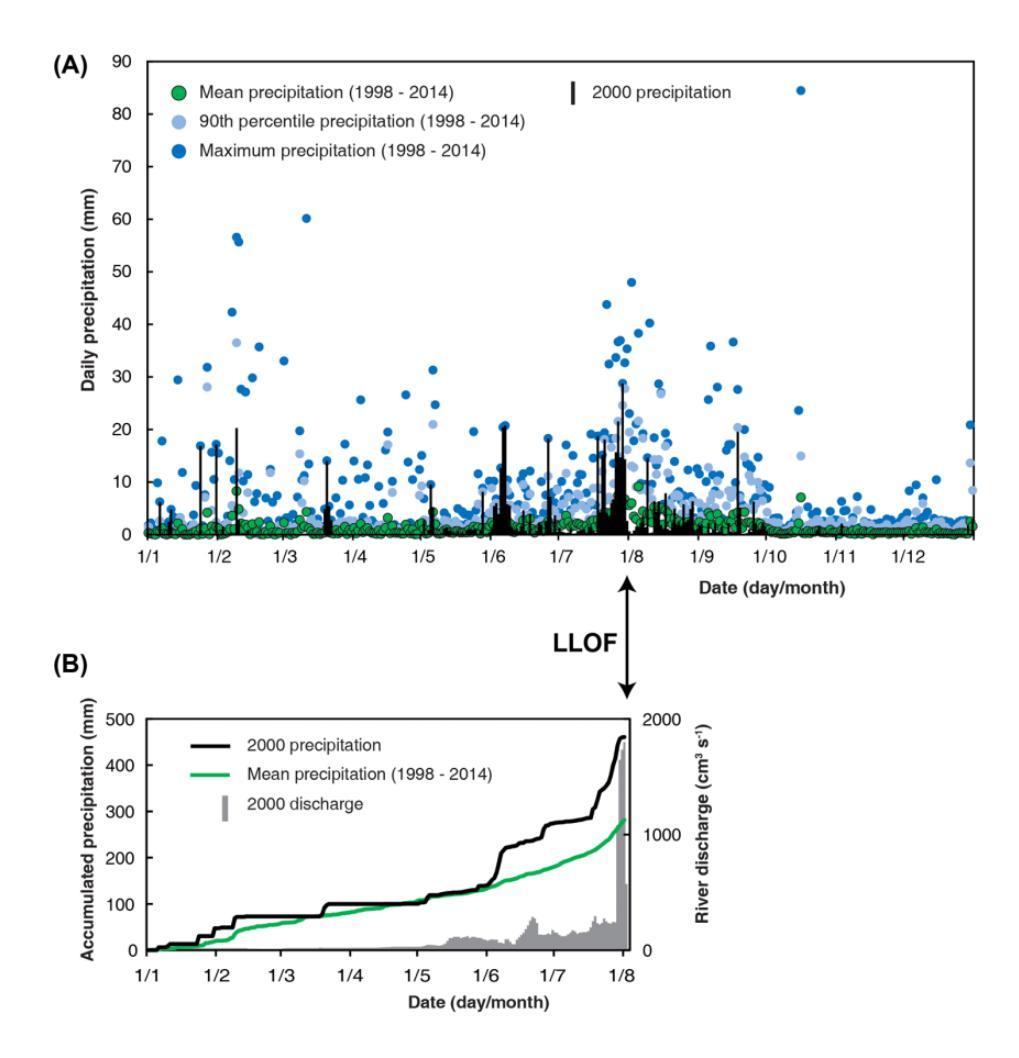
Figure 8. TRMM area averaged daily precipitation over the watershed area of the unnamed Tibetan lake: (a) Daily measurements during 2000 are compared to the longer-term (1998–2014) mean, maximum, and 90th percentile values. (b) Accumulated daily precipitation in 2000 is compared to the longer-term mean and with daily stream discharge measurements at Khab during 2000.

In the year 2000, precipitation during winter and spring had been about average (Figure 8), with snowline elevations mostly positioned higher than normal throughout April and June (Figure 6(b)). These observations are consistent with stream discharge on the Sutlej River being more or less normal at this time (Gupta and Sah, 2008). However, throughout June and July, the catchment area of the unnamed lake received sustained and occasionally very heavy precipitation, with 320 mm in total measured over these 2 months (compared to 144 mm as a longerterm average over the same period; Figure 8). Particularly in the latter half of July, rainfall intensities significantly increased,

coinciding with the arrival of the monsoon front centred over the upper Sutlej basin (Figure 7(b)). The exponential increase in accumulated precipitation over the unnamed lake catchment broadly corresponds with the increase in Sutlej discharge measured during July 2000 (Figure 8(b)).

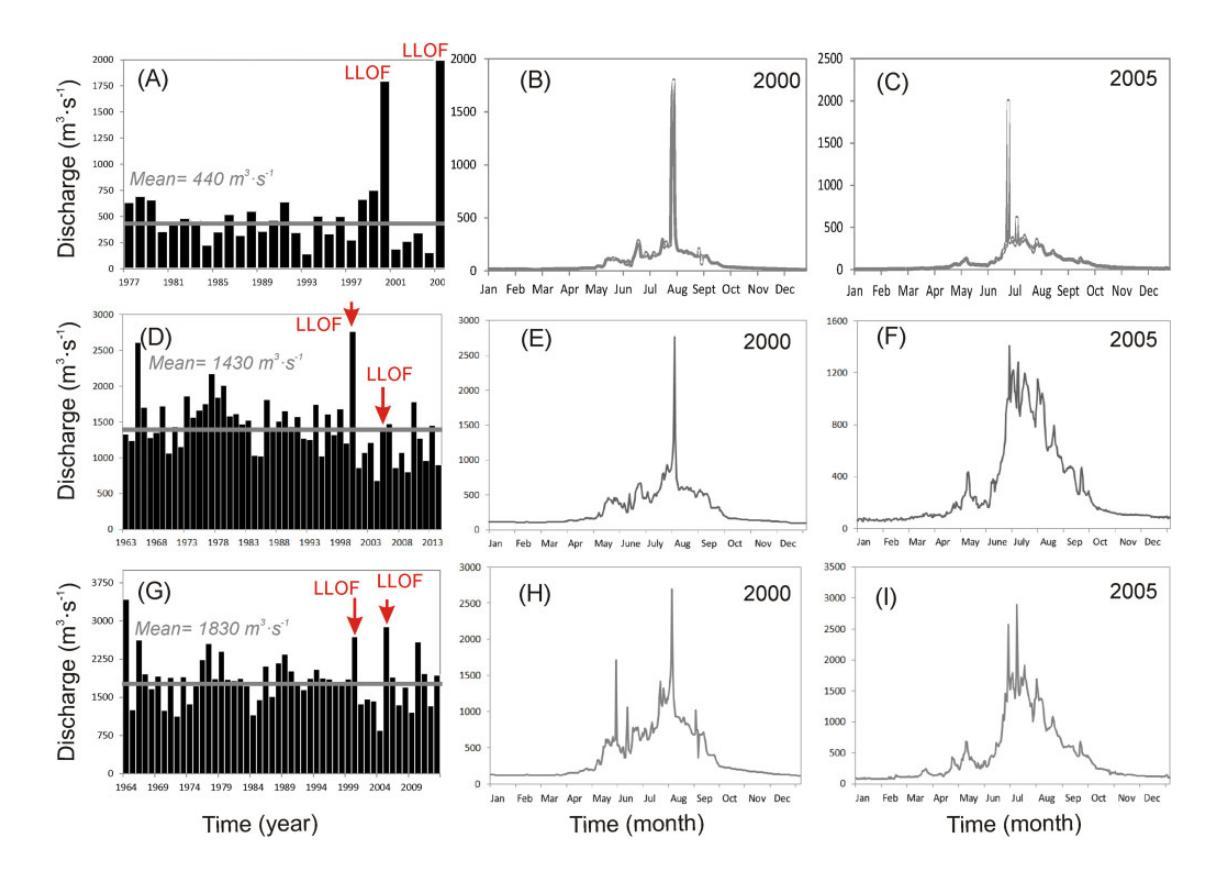
Figure 9. Annual maxmum discharge series and 2000/2005 daily discharge recorded in the Sutlej River at Khab (a, b, c); Rampur (d, e, f) and Kasol (g, h, i). Data of peak discharges in 2000 and 2005 at Khab are based on reconstructions and data from Gupta and Sah (2008). Mean shows the mean value for the common period 1980-2000.

Analysis of the available discharge data shows inconsistent and incomplete values for the 2000 and 2005 flood events (Figure 9). However, we should reiterate that the most upstream station at Khab was damaged during both events and did not record the outburst floods properly. Our reconstruction based on the correlation with other stations resulted in a lower value equal of $731 \text{ m}^3 \text{ s}^{-1}$ with an upper limit of $1100 \text{ m}^3 \text{ s}^{-1}$ for the event in 2005, and a range between $676 \text{ m}^3 \text{ s}^{-1}$ and $1024 \text{ m}^3 \text{ s}^{-1}$ for the 2000 flood. These values are relatively low as compared to reported data and the values provided by Gupta and Sah (2008), with a maximum discharge close to 2000 m³ s⁻¹ in 2005

and 1800 m³ s⁻¹ in 2000 (plotted against our records in Figure 9).

The discharge recorded at Rampur in 2005 was not significantly high, while at Kasol the flood in 2005 was the second highest after an earlier event recorded in 1964 (Figure 9(a), (d) and (g)). Inconsistencies between the two lower stream gauges suggest they might also have been damaged during the floods. In Rampur the maximum discharge recorded during the 2000

Daily discharge data from 2005 reveals a notable increase starting already in early June, at all three downstream stations (Figure 9(c), (f) and (i)), despite the lack of any notable precipitation falling over this time (Figure 5). This strongly suggests that despite a relatively cold spring, snow and ice melt was the critical factor in raising water volume in Parchu Lake to catastrophic levels. The overall quantity of meltwater draining from the catchment area was likely larger than normal, owing to the significant precipitation events recorded during January and February.

event. As reported by Gupta and Sah (2008), average daily discharge at the beginning of June 2000 was 80 m³ s⁻¹ (Figure 9), and after mid-June it started rising to reach maximum values of 126 m³ s⁻¹ by the end of the month. In July a nearcontinuous increase in discharge was observed immediately before the peak LLOF event.

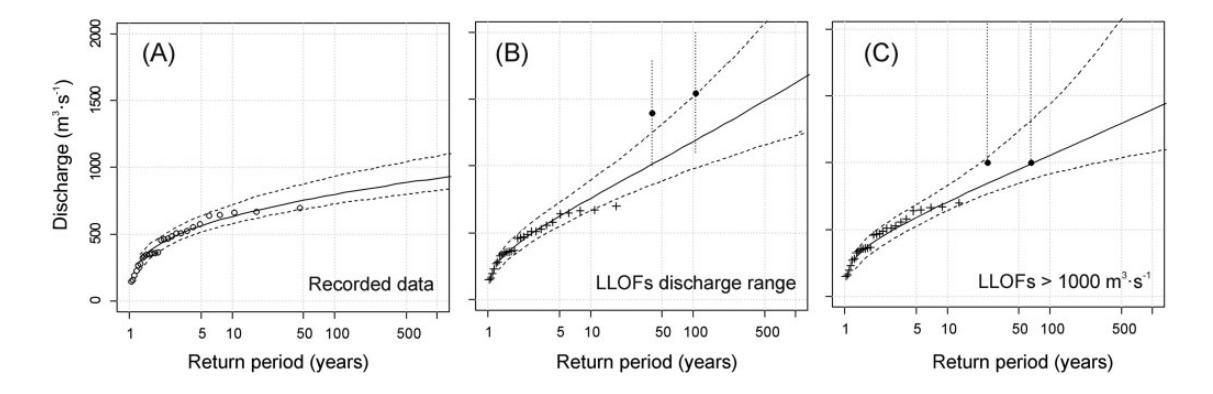
Figure 10. Fitted log-Pearson type III distributions of return periods of specific discharges based on the instrumental data at Khab (a) without the estimated discharge in 2000 and 2005; (b) adding the two events with the estimated ranges to the data series and (c) adding the threshold of $1100 \text{ m}^3 \text{ s}^{-1}$ which was reached at least two times over the last 100 years.

which was reached at least two times over the last 100 years as we report here (Figure 10).

The main observation extracted from the FFA analysis is that the quantiles for extreme events - usually used for flood risk assessments - increased significantly when the LLOFs events are included in the analysis. The 100-year flood increased from 724 to about 946 $m^3 s^{-1}$ (ranging between 914 $m^3 s^{-1}$ and 977 m^3 s^{-1}). This means that more extreme floods might be considered to happen more frequently, so the counter measures to reduce flood hazard and risk should be reconsidered. However, the frequency of the landslides that caused the floods might be very different from the frequency of a flood triggered by other factor (i.e. intense precipitation), and the frequency estimated by this method does not consider different triggers of floods. A catastrophic outburst flood can only occur if sufficiently large amounts of water have been retained behind a landslide dam in the first place. Furthermore, a dam failure mechanism (e.g. overtopping, displacement wave) must provide the opportunity for large water masses to escape in a relatively short time (Worni et al., 2013). Overtopping of the dam crest may occur during high-magnitude floods, and thus needs to be formulated as a

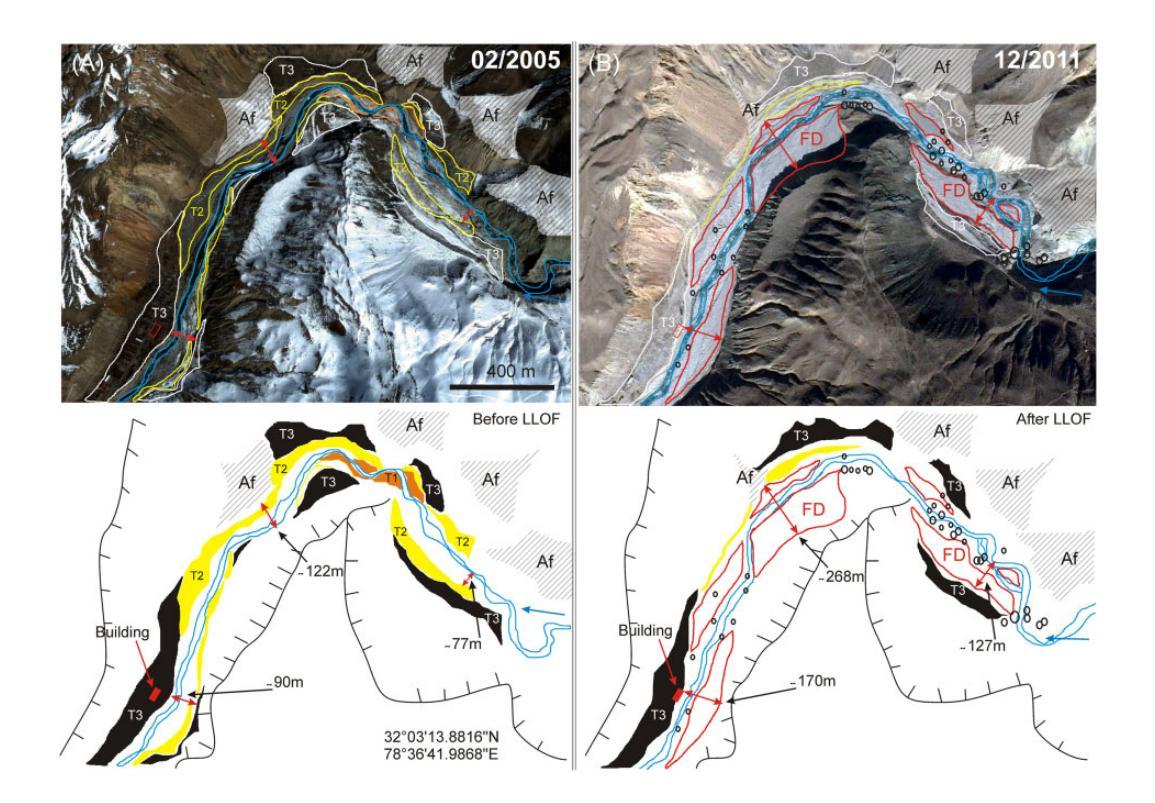
Figure 11. Geomorphic maps of the Parchu River upstream from its confluence with the Spiti River, close to Samdo village (a) in February 2005 (before the LLOF) and (b) in December 2011 (after the LLOF). T1, T2 and T3 are different levels of terraces; FD are flood deposits after the 2005 LLOF; small black circles are big boulders transported during the LLOF; red arrows indicate river widening during the LLOF and approximate values are shown; AF are alluvial fans; the blue line represents the low flow channel. Small red square shows a building in the most severely affected, populated area (there were several more). Images are from Google Earth.

Figure 10 shows the significant geomorphic imprint that the 2005 LLOF left on the Parchu River (tributary of the Sutlej River), upstream of one of the most affected and heavily populated areas. The river widening was on average about 65 m in this reach, ranging locally between 50 and 150 m. Terraces and alluvial fans were completely eroded (such as T1 and T2, and the most downstream alluvial fan in Figure 11) and the flood deposited large amounts of (fine) sediment and boulders.

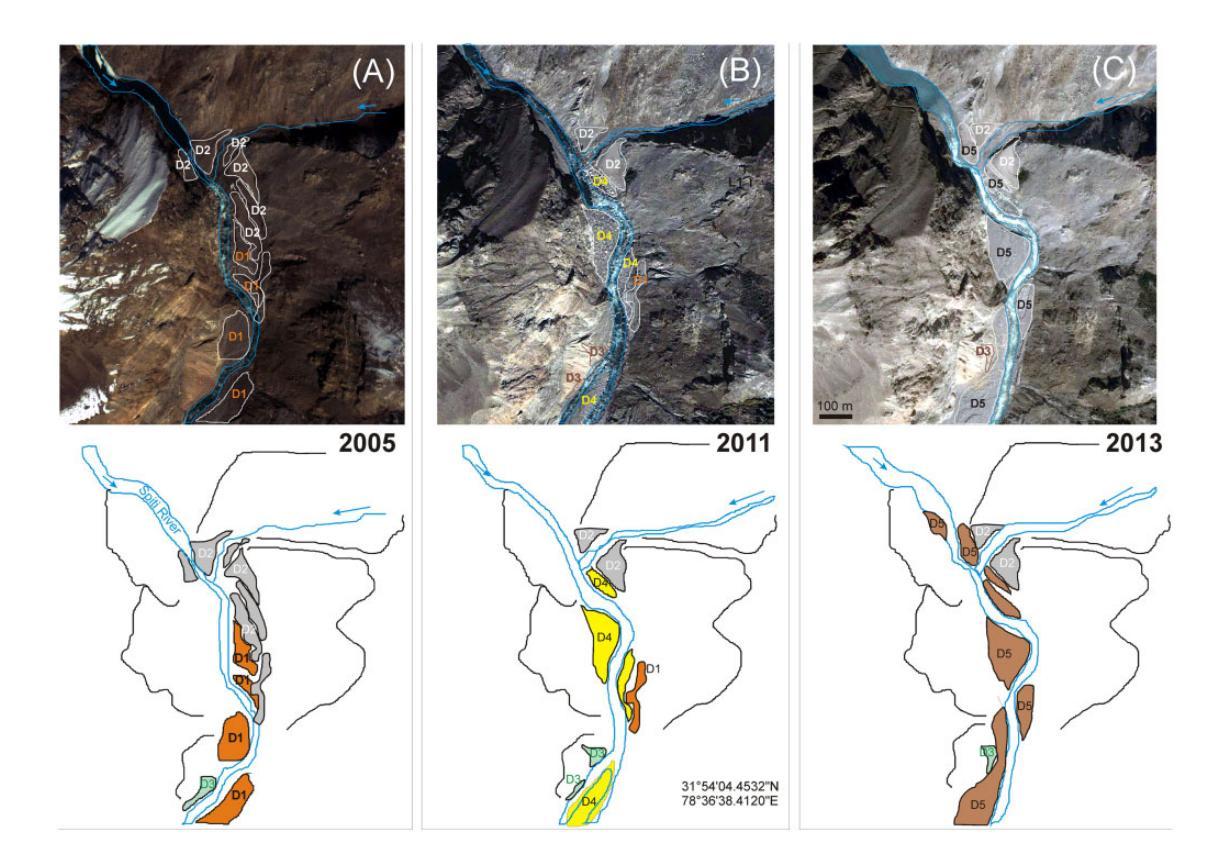
Figure 12. Small debris flow fan damming of the Spiti River close to Leo (downstream confluence with the Parchu River): (a) river damming prior to 2005 leaving deposits here referred to as D2; (b) between 2005 and 2011 when the river shifted and removed most of the D1 and D2 deposits but leaving new deposits (D4); (c) in 2013, most of the D4 sediment is eroded but sediment is supplied from upstream the tributaries such that the river aggradated between 2011 and 2013, forming a series of new bars (D5). Images are from Google Earth.

this is not only true for the two cases analysed in this work. As observed in other regions (Whitehouse, 1983), we observed differences in channel morphology downstream and upstream of dams with lower river gradients above the deposit, along with marked aggradation, whereas incised streams and gorges occur below or at the level of the deposit. Connectivity between hillslopes and the river makes landslides and debris flows the main sediment sources to the river. Figure 12 shows, by way of example, how sediment dynamics may work as a result of river damming in the Spiti River.
